B-1412

Redemptorist Row
219-237 Park Avenue
Private

State Historic Sites Inventory Form

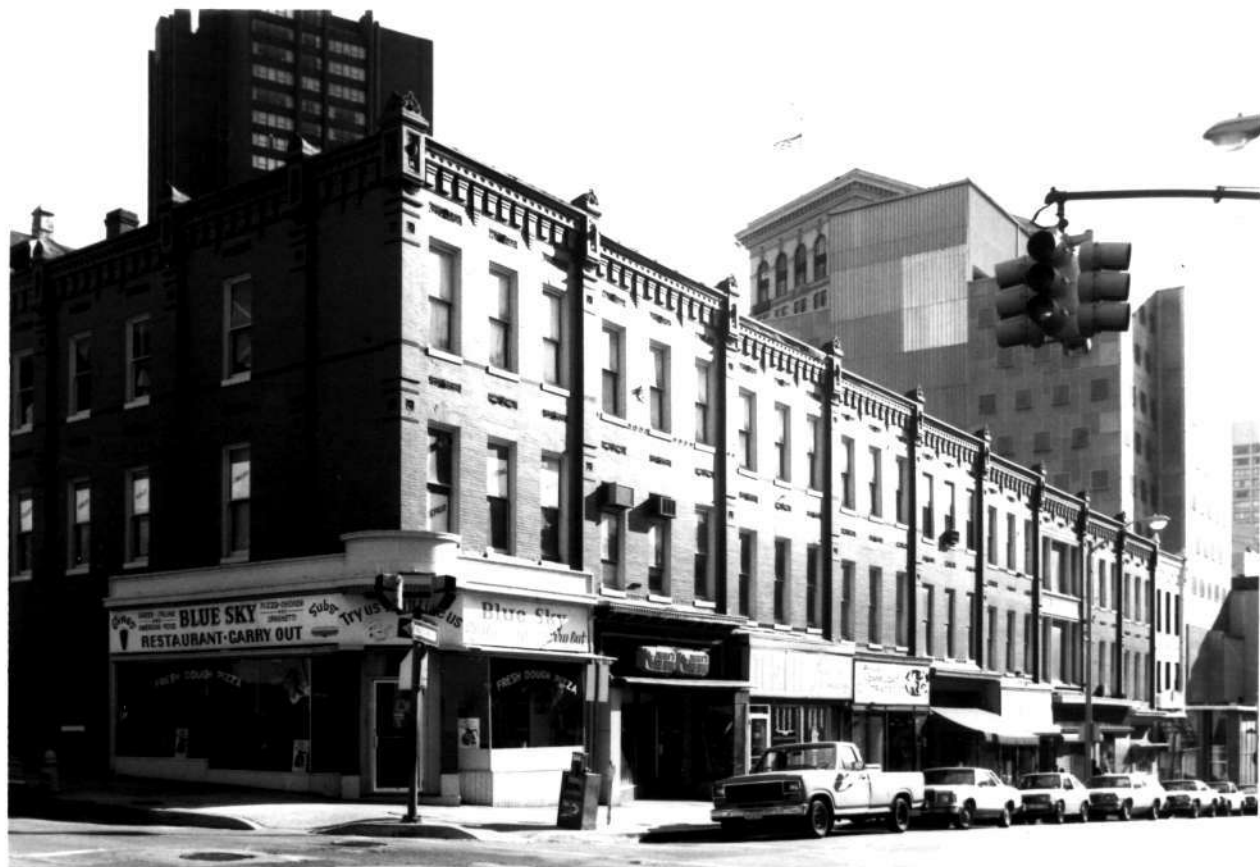
Redemptorist Row B- 1412
219-237 Park Avenue
Market Center - Metrocenter Survey
Baltimore (City), Maryland
Photo: Janet Davis
November 1985
Neg. loc.: Maryland Historical Trust
Northwest corner view
1/3

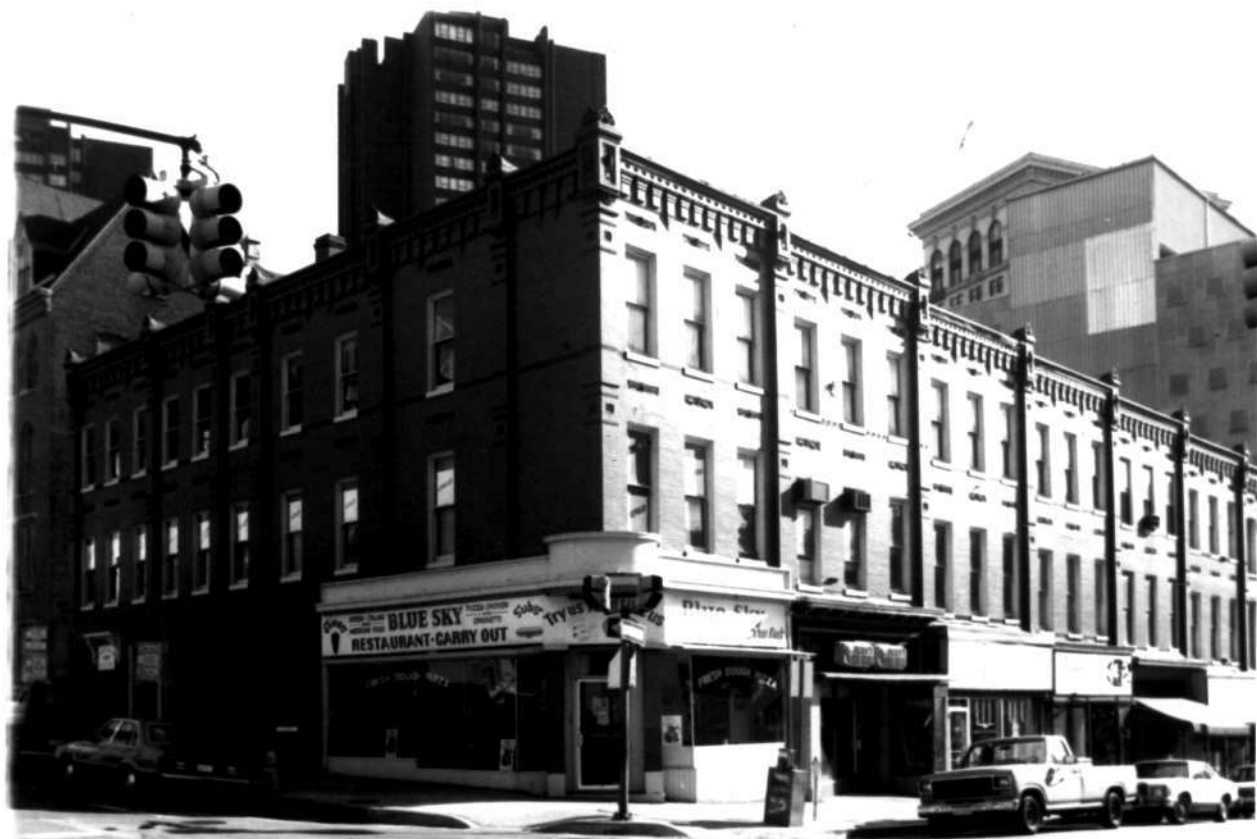
Redemptorist Row
219-237 Park Avenue
Market Center - Metrocenter Survey
Baltimore (City), Maryland
Photo: Janet Davis
November 1985
Neg. loc.: Maryland Historical Trust
Northwest corner view with Saratoga
St. elevation
2/3

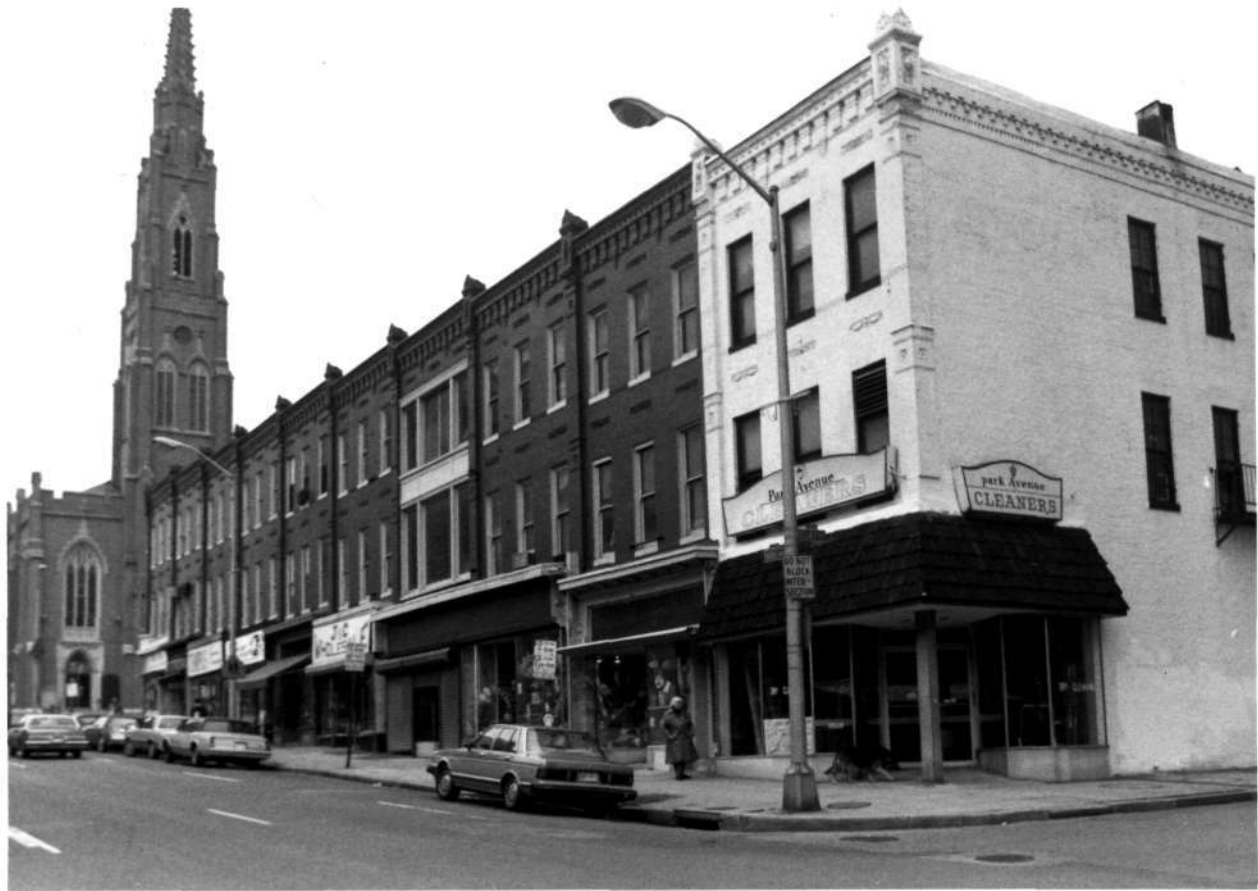
Redemptorist Row B-1412
219-237 Park Avenue
Market Center - Metrocenter Survey
Baltimore (City), Maryland
Photo: Janet Davis
November 1985
Neg. loc.: Maryland Historical Trust
Southwest corner view
3/3
